**FORD'S WAY**  
**EVOLUTION OF THE**  
**A-9020**  
**GAS/COWL TANK FILLER SCREEN ASSEMBLY**  
**AND**  
**A-9032**  
**GAS TANK FILLER FLANGE ASSEMBLY**  
**PART 2**  
**BY**  
**STEVE PLUCKER**  
**JUNE 8, 2009**

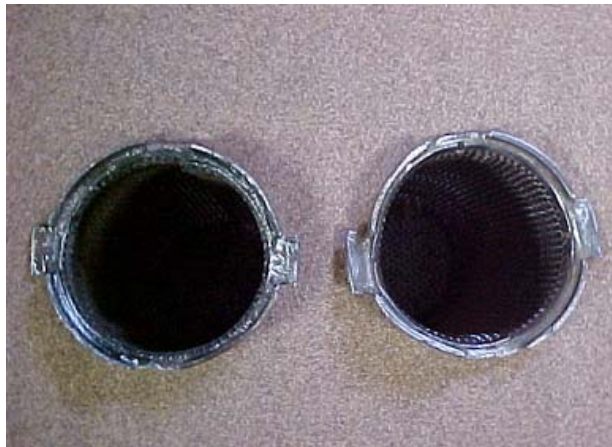
(Fig.4)

As the new 1930 models were being designed, so was the A-9020 Gasoline Tank Filler Screen Assembly. On November 9, 1929, PR # 14489, the old style screen assembly with the steel screw-on “screen head” was to be replaced with one which had 3/8 inch wide steel “lugs” or “tabs” (**Fig. 4 Left**) to hold it in place within the new style (Type 2) A-9032-B (Copper Plated) Gas Tank Filler Flange Assembly (**Fig. 3**). The old style screen assembly (screw-on) thus became A-9020-AR and the new style screen assembly (with tabs) became A-9020-B. The fuel tank part numbers also changed due to the changes within. The original 28-29 tank became A-9002-A1 which signified the screw-on filler flange; the 28-29-early 30 tank, for which was utilized with the 1930 A commercial and AA Trucks, excluding the 1930 150-B Station Wagon, became A-9002-A2. It was the same identical tank as the A-9002-A1 except it utilized the new 1930 “Easy-On” type filler flange which also took the new A-9020-B Gas/Cowl Tank Filler Screen Assembly with the 3/8 inch tabs and new 1930 gas cap. The new 1930 tank, A-9002-B, also utilized the new Zinc Plated screen assembly.

On February 24, 1930, PR # 15663 specified that the width of the lugs or tabs and slots were widened from  $\frac{3}{8}$  inch to  $\frac{1}{2}$  inch to lessen any possibility of breakage of the lugs themselves (**Fig. 4 Right**). This feature was also indicated in the March 1930 Ford Service Bulletin thus indicating that a heavier gauge of material was also being used in the manufacture of the new part. The part number, however, remained the same.

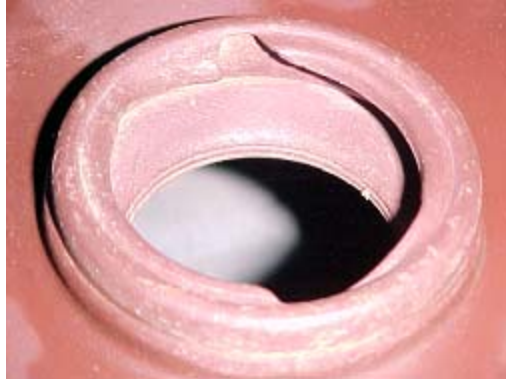
(Fig. 5)

This also required a change in the A-9002-C tank during this time as a new style (Type 3) A-9032-C (Copper Plated) Gas Tank Filler Flange Assembly was also changed to accept the reinstated A-9020-A filler screen assembly with the screw-on "screen head" but retained the "Easy-on" type of gas cap (**Fig. 5**). However, there may be some early 1931 tanks which still possess the Type 2 Gas Tank Filler Flange and the "tabby" type filler screen assembly. This feature remained the same, including its use on the 1931 A-9002-E tanks which were used with the indented firewalls, throughout the production period of the Model A and AA Ford.
