The  
1928-1931  
Model A Ford  
Universal Joint Housing Caps—inner and outer  
And  
Transmission Main Shaft Bearing Retainer  
Assemblies  
By  
Steve C. Plucker  
as of  
October 13, 2006  
(Revision # 8)

The following study concerns the 1928-1931 Model A Ford Universal joint housing caps—inner and outer assemblies (and related parts) along with its counter part, the Transmission main shaft bearing retainer.

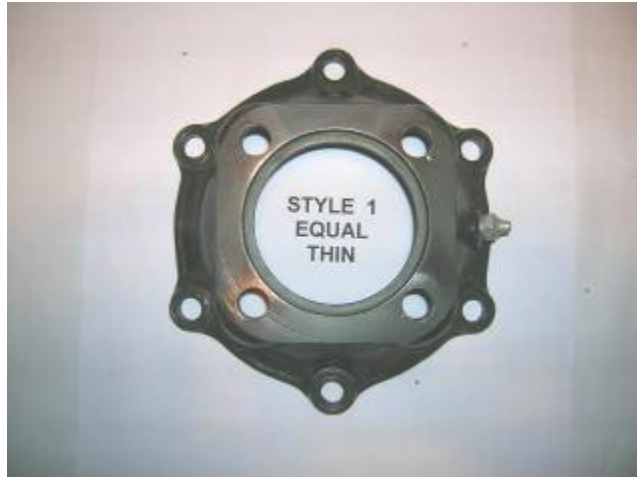
Fig. 1

The Transmission main shaft bearing retainer was represented by part number A-7085 and A-7085-A (Fig. 1). The six (6) bolt hole flanges were  $\frac{1}{4}$  inch in thickness and referred to as the **thin** type, it had a large center hole and raised “hump like” center areas on all four sides on the outside of the retainer. The grease zerk was on the middle right side of the retainer. These were stamped with the “Ford” script in various spots on the retainer. A good photo of its placement on the back of the transmission can be seen on page 236, Fig. 484 of the March, 1928 Ford Service Bulletin.

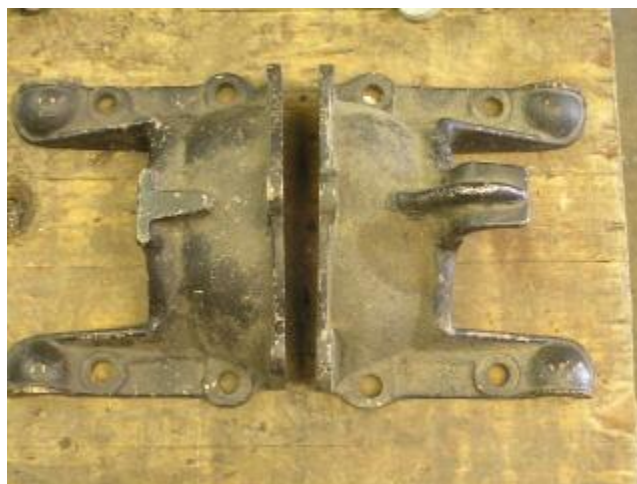
Fig. 2

The Universal joint housing cap—outer assembly, had no known individual part numbers at the time except as a complete assembly, A-4514-C. However to simplify things the upper half was known as A-4518 and the lower half was known as A-4514. There were two (2) known varieties of the “outer” assembly. Variety 1, (Fig. 2) has a safety lug with a raised, pronounced rib going up the center of the lug on the upper half. On the lower half there is a “T” type boss to position the safety lug which was to be welded on but was not. This variety has been confirmed on \*A189\*, owned by Mr. Charlie Bass, which was stamped on November 2, 1927. Variety 2, (Fig. 3) has the revised safety lug which was half round with no pronounced rib on the upper half. The lower half had a “D” shaped boss to position the safety lug which was to be welded on but was not. This variety has been confirmed on \*A1031\*, owned by Mr. Steve Ciccalone, which was stamped on December 1, 1927. It is not known when Variety 1 was discontinued or when Variety 2 began. The releases did not say.

Both halves had extension arms for the service brake equalizer brake system. Both varieties had 1/4 inch wide oil or grease grooves extending the length of the extended arms on the lower half only. The reinforcement ribs in the corners of the arms on Variety 2 were 1-1/16 inch in height, upper and lower, but were 1-3/16 inch in height on Variety 1 lower and unknown on the upper.

A good example of the lower part of Variety 1 can be found on page 222, Fig. 451 of the February, 1928 Ford Service Bulletin. If you have early copies of the Ford Parts Price List's, the pronounced “rib” can also be seen on the upper half of the outer housing, A-4520.

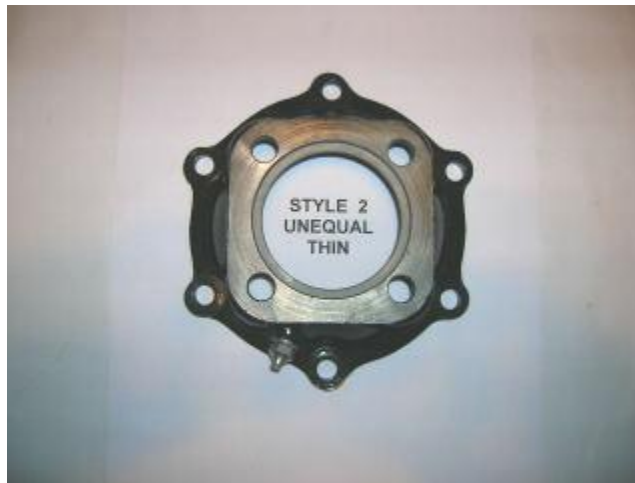
Fig. 4

The Transmission main shaft bearing retainer, represented by part number A-7085-B (Fig. 4), still had **thin** flanges, raised “hump like” center areas on all four sides of the retainer and still retained the large center hole. The only major change to this part was that the grease zerk was moved to the right 60 degrees to the bottom of the retainer where it remained throughout production. The “Ford” script is also on early styles of these retainers but was removed after late March, 1928 “for the convenience in exporting”!

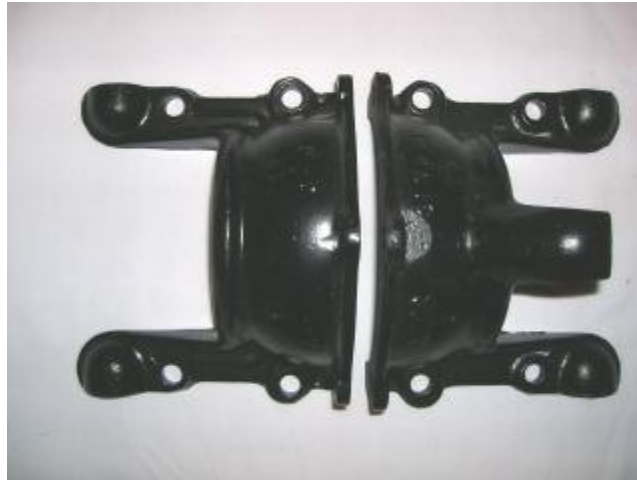
Fig. 5

The Universal joint housing cap—outer assembly, represented by part number A-4520 (Fig. 5), finally started to distinguish that the upper half of the assembly was A-4518 and the lower half was A-4514. The upper half, A-4518, still had the half round “D” shaped safety lug which was still being welded onto the part. The corner reinforcement ribs started out at 15/16 inches in height. However on December 30, 1927 they were reduced to 13/16 inches. The lower half, A-4514, also went through some changes. The “D” type boss, which was on Type 1, Variety 2, was removed. The reinforcement ribs changed in height from 1-1/16 inch to 3/4 inch in mid December, 1927. Sometime between December, 1927 and February, 1928, the oil or grease grooves on the extended arms were changed from 1/4 inch to 1/8 inch in width. However on February 13, 1928, the grooves were changed to 3/16 inch in width.

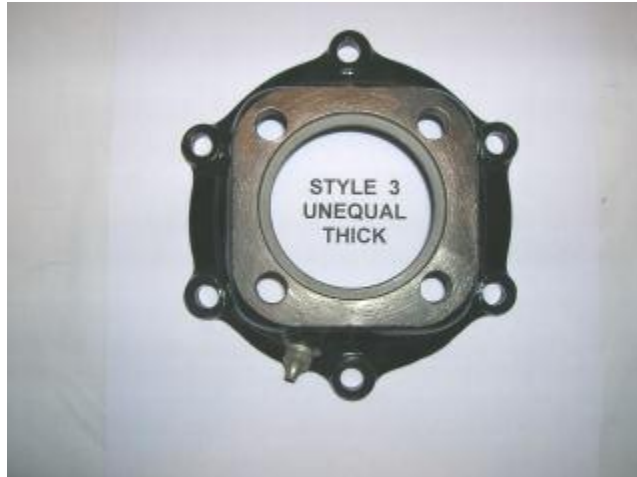
Fig. 6

The Transmission main shaft bearing retainer, represented by part number A-7085-C (Fig. 6), was a casting. However when it was redesigned, the six (6) bolt hole flanges changed from **thin** to **thick** and the four sides of the retainer were changed to flat, not “hump like” as with the two early styles. It still retained the large center hole and the grease zerk on the bottom of the retainer.

More than likely Ford changed the thickness of the six (6) bolt hole flanges on the Transmission main shaft bearing retainers due to the casting as they were not as strong as the forgings. At the start of production, the flanges were about  $\frac{1}{4}$  inch in **thickness**. By October, 1928, Ford went to **thicker** flanges which made them about  $\frac{5}{16}$  inch **thick**. An increase of  $\frac{1}{16}$  inch in **thickness** (Fig. 7). This also changed the bolt lengths which were used to connect the Universal joint housing caps—inner and outer by  $\frac{1}{16}$ <sup>th</sup> of an inch.

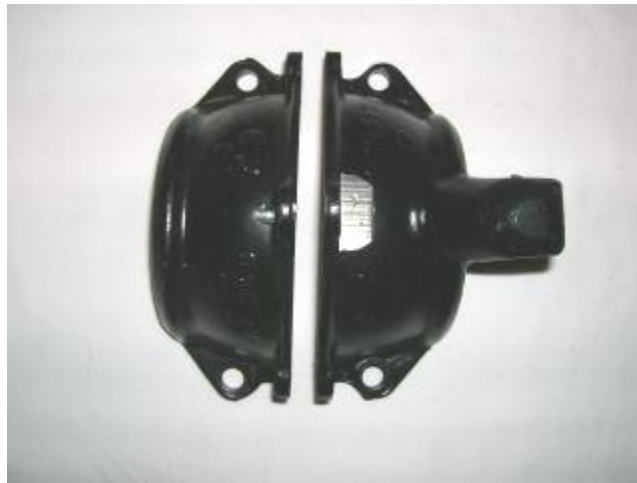
Fig. 8

The Universal joint housing cap—outer assembly (Fig. 8) was represented by part number A-4520-B. Both the upper and lower parts had the extended arms removed, as they were not needed for the new braking system. During the redesigning, both parts, whether forged or casting, had the thickness of the web between the bolt boss and the rear corner changed making it the same thickness as the boss. The edge between the bolt boss and the rear corner was also changed from being curved to being straight (Fig. 9). But may be found both ways. The upper half had three known part numbers, A-4518-B, which was a forging; A-4517-B1, unknown (have not viewed this part but may be a forging); and A-4517-B2, which was a casting or Malleable Iron Design. All three retained the safety lug. However with the “castings”, the lugs appeared to be formed with the part itself and not welded on as with the forgings. The lower half also had three known part numbers, A-4514-B, which was a forging; A-4514-B1, a forging (have not viewed this part); and A-4514-B2, which was a casting.

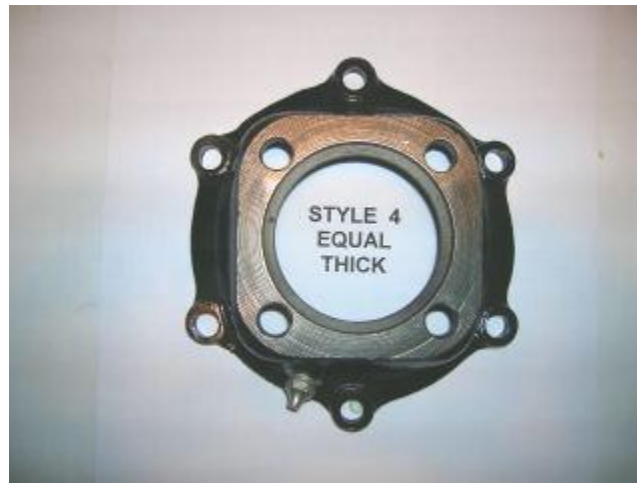
Fig. 10

The Transmission main shaft bearing retainer was represented by part number A-7085-A (Fig. 10). Some have A-7085-A1 stamped on them. It was identical to A-7085-C except it now had **equal** spaced holes. It retained the large center hole, **thick** flanges and it's construction was the Malleable Iron Design.

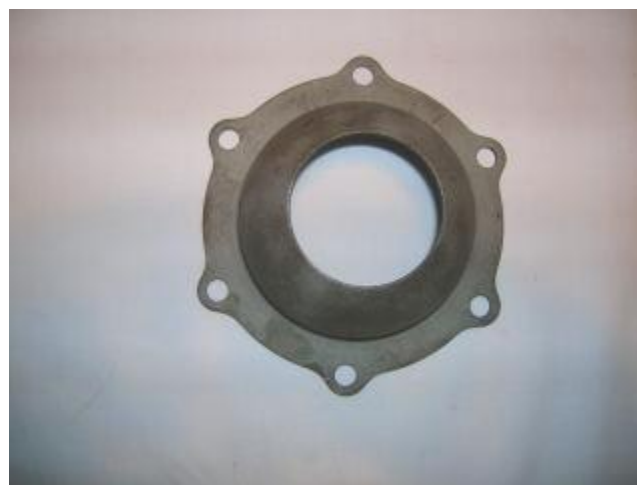
Fig. 11

The Universal joint housing cap—inner, reverted back to the original part number of A-4513-A (Fig. 11). In actuality it was the same as the first style but the only difference was that there were two 3/8 inch holes punched into the side of the bell portion for extra lubrication of the Universal Joint Assembly, A-7090. The large hole in the bell portion was 2-9/32 inch diameter and remained as such throughout production. Some inner later caps have been seen without the two 3/8 inch holes. Some inner earlier caps have the two 3/8 inch holes drilled on the side which the service department may have done due to the explanation in the June, 1929 Service Bulletin.

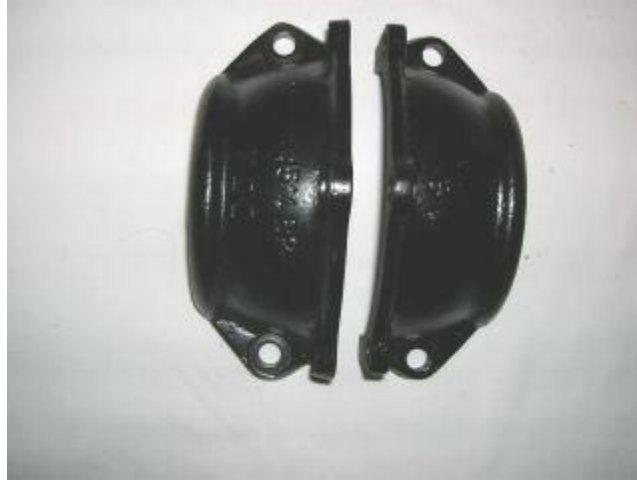
Fig. 12

The Universal joint housing cap—outer assembly, took on a new part number of A-4520-C. Ford had decided to remove the extension or safety lug on the upper universal joint housing cap thus “obsoleting” or discontinuing A-4518-B, A-4517-B1 and A-4517-B2 upper cap completely as “the lug is no longer necessary”. The upper cap was replaced with the lower cap, A-4514-B2 (Fig.12) which made the assembly **equal** spaced. It was explained in the June, 1929 Ford Service Bulletin that “This change eliminates the necessity of **unequally** spacing the bolt holes in both this part and its corresponding gaskets (not to mention the Universal joint housing cap—inner and the Transmission main shaft bearing retainer) as the **unequal** spacing was used simply to insure that the housing cap being assembled with the extension lug toward the top”. With the safety lug becoming obsolete on March 15, 1929, some upper halves of A-4518-B’s, which had been forged, may have just the “D” boss and not the safety lug.

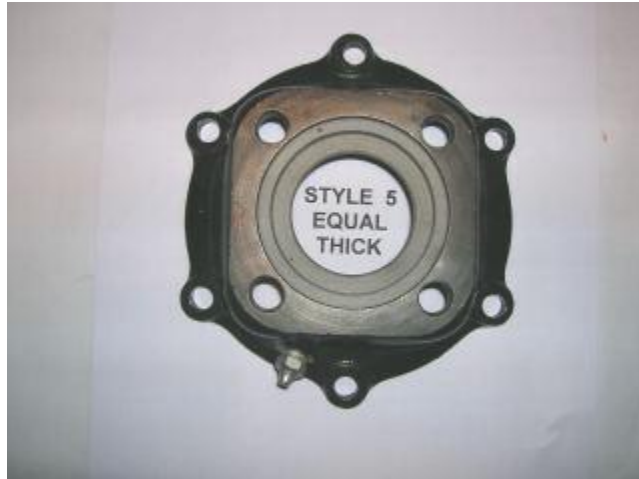
Fig. 13

This leads up to the final assembly, Type 5. The parts used in this assembly were the same exact parts as what was used in Type 4 assembly except for the new Transmission main shaft bearing retainer, A-7085-A1 (Fig. 13). Just when this retainer went into actual production is anybody’s guess...any time from late June to September, 1929 and was continued in use through the production of the Model A Ford.

Type 4 assembly lasted but a few short months when on June 22, 1929, Release # 13297, Ford redesigned the Transmission main shaft bearing retainer. A flange was added to the large center hole which reduced it’s size from 2-1/2 inches to 2-27/32 inches. It was finally reported in the September, 1929 Ford Service Bulletins about 100 days later and was done to “reduce any possibility of oil leakage through the rear transmission bearing”.
