FORD'S WAY

“BRAKE SHOE AND LINING PRODUCTION”

A Historical View of Model A/AA Production Practices 1928-1931

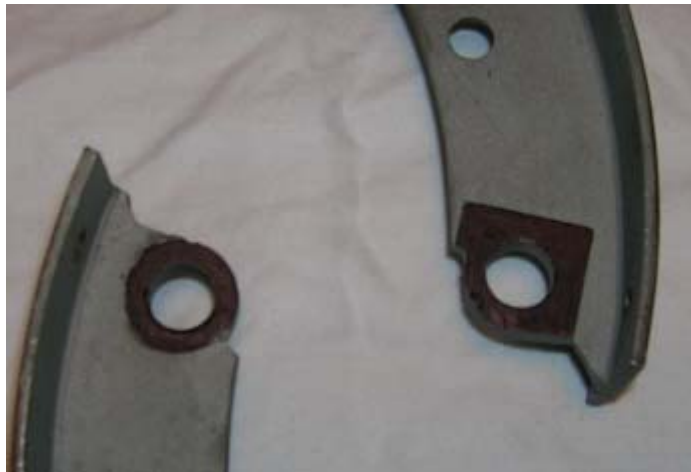
Fig. 1

Contained in the May 15, 1928 issue of Ford News was an article explaining the operation in welding the A-2022: Brake Shoe Reinforcement Lugs on to the A-2020: Brake Shoe. The photo in this article clearly shows that the individual lugs were "square" before the "final finish" as seen on many brake shoe assemblies (**Fig. 1**) which have part of the original squared lug ground off.

There was also another type of reinforcement lug which was attached to the brake shoe. This was a round washer type lug (**Fig. 1**).

It is interesting to note here that according to the part releases associated with the A-2022: Brake Shoe Reinforcement Lug, on April 25, 1928, Part Release Number 8425, the lug was "Redesigned", from what to what it did not say. However on December 13, 1928, Part Release Number 11331 tells us that the lug was "*Changed from 3/4 inch diameter (indicating the diameter of the washer type lug) to 7/8 inch square (indicating the square type lug)*". That being the case, the assemblies started out with square lugs, changing to round lugs, and then went back to the square lugs. I wonder if any front fenders exist with the "round" type of lugs as I have never seen any?

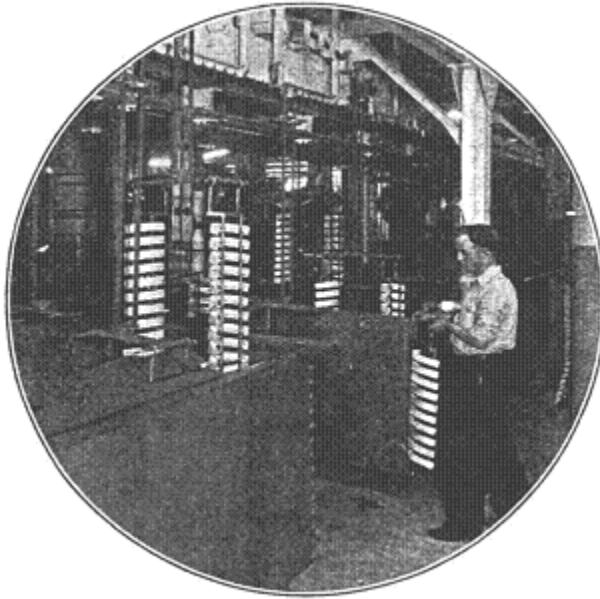
Fig. 2

“Suspended from the overhead track are seventy-six narrow rods, or hangers, each of which supports two racks on which the brake shoes are arranged. The racks will hold thirteen brake shoes each, so that so that when all the hangers are filled to capacity, a total of 1,976 brake shoes can be sent through the tank and plated at one time (Fig. 2)”.

“The operation takes place in a tank 40 feet long, 6 feet wide and 4-1/2 feet deep, somewhat resembling an irrigation flume. The tank contains 6,000 gallons of cadmium solution, through which the brake shoes must pass. The passage is effected by the automatic conveyor referred to”.

“Slightly more than half an hour is required for the complete journey through the tank or ‘revolution’. Before entering the main tank, the materials are cleaned in muriatic acid. Then they are washed in a cleansing tank filled with a solution of tri-sodium phosphate and soda ash. After this bath, the shoes are rinsed in a second tank which holds clear water. Then they are ready to start on their journey”.

“As they pass slowly along the tank, the hangers dip the shoes in, time their period of bathing, hoist them out, re-dip them, and finally lift them out at the end of the cycle, right at the place for which they started. Simple to operate, it has enabled the department to increase its production ten times over that when the old hand methods were used”.

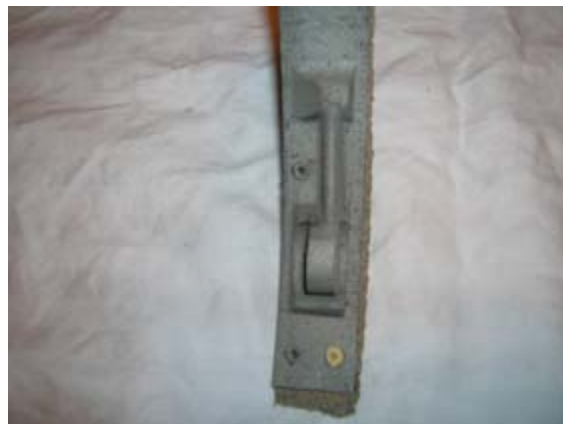
Fig. 3

The first style had twenty-five parts associated with it. Each band had one (1) A-2610 (-A1): Emergency Brake Band Assembly; two (2) A-2613-14: Emergency Brake Band End Fittings, R.H. & L.H. (forged) (**Fig. 3**); two (2) A-2617: Emergency Brake Band Spring Connections plus four (4) rivets to hold them in place; one (1) A-2620: Emergency Brake (Band) Lining; and fifteen (15) A-xxxx rivets to hold the lining in place.

The two end fittings, A-2613-14, were about 4-1/4 to 4-3/8 inches in length and were "welded" to A-2610 to make up the assembly.

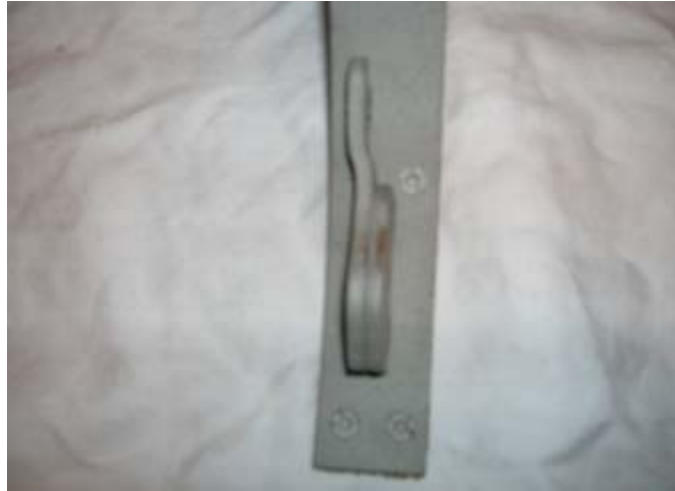
Fig. 4

The second style, had twenty-six parts associated with it. Each band had one (1) A-2610-A2: Emergency Brake Band Assembly; one (1) A-2615 (RH) and one (1) A-2616 (LH): Emergency Brake Band Ears (**Fig. 4**); two (2) A-2617: Emergency Brake Band Spring Connections plus four (4) rivets to hold them in place; two (2) A-2618: Emergency Brake Band Bar Reinforcing Plates (**Fig. 4**); one (1) A-2620: Emergency Brake (Band) Lining; and fifteen (15) A-xxxx rivets to hold the lining in place.

On August 12, 1929, it was "Specified that the lugs (A-2615-16 and A-2618) may be cold riveted or welded to the band instead of welded only".

According to the October 18, 1929 Ford Service Letter-Indianapolis, this style was developed to provide a better and fuller contact of the brake shoe lug and the brake plate stop. The redesigning of the emergency brake band was mainly due to its wedging between the stop on the emergency carrier plate and the brake drum resulting in the locking up of the brake itself which might have been attributed to the driver starting the car in low gear without releasing the emergency brake. Abuse of this kind soon distorts and bends the brake carrier plate stop, thus permitting the brake shoe to wedge itself against the drum.

The Engineering Department then changed the angle of the brake shoe lug bearing against the stop, making it radial instead of parallel with the brake band assembly.

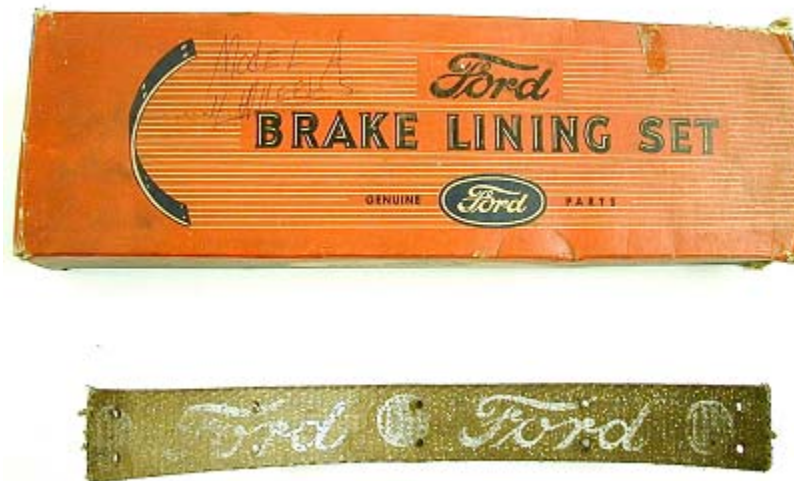
Fig. 5

It was "specified" on December 28, 1927, Part Release Number 6078, that the "name FORD in script and trade mark be printed on unground side about 12 inches apart" on the stock coils. This was changed to "6 inches" on January 26, 1928, Part Release Number 6820 (Fig. 5). The trademark was a circle with US in the center.

The February 5, 1930 Ford Service Letter-Indianapolis indicated that "We are using several types of woven (Fig. 5) and semi-moulded braking linings (rubber) (Fig. 6), which have been approved by the Engineering Department of the Ford Motor Company. About 50% of our present production is a semi-moulded lining (rubber), marked T.R.C. (Fig. 6). With these linings, it is difficult to score the brake drums and it is recommended that these linings be used on cars that demand exceptional braking performance, such as Taxi-cabs or Model A commercial units".

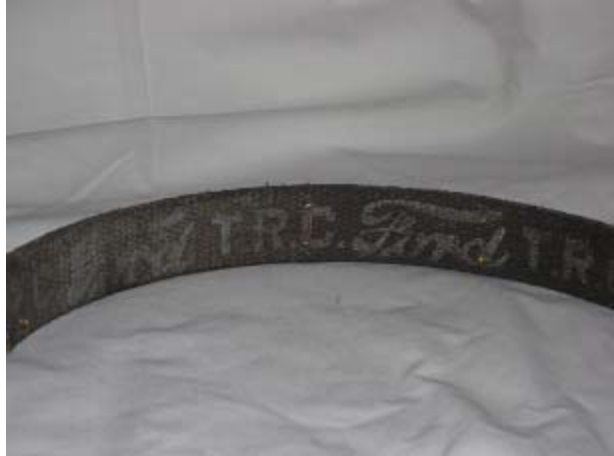
Fig. 6

T. R. C. stood for the Thermoid Rubber Company in Trenton, New Jersey who were the makers of interwoven molded rubber based automotive brake linings.

The use of the rubber semi-moulded brake linings was also confirmed on March 29, 1930, Part Release Number 15979, that the *“thickness be 0.162-0.172 for rubber composition linings and thickness for the woven lining remain the same (0.172-0.182)”*.
