The Evolution Of THE MODEL A FORD FRAME ASSEMBLY

A-5005-A, B, C and D

According To Ford Engineering Releases

By *Steve Plucker, Touchet, Washington*

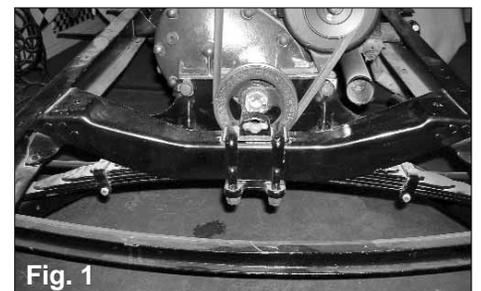
Frame Assembly A-5005-A had what is called a 3-piece front cross member (**Fig. 1**). It consisted of parts A-5023 and A-5024, which were referred to as the Front Cross Member To Side Member Bracket, R. H. and L. H and were riveted to the front corners of the cross member. These were specified on October 27, 1927, Release Number 3574 as "New number, new part, 1 req. right hand and left hand A chassis 1928." It also indicated that this three-piece front cross member assembly was to be used on the first 200 cars only. The middle portion of the 3-piece front cross member was referred to as the Frame Front Cross Member, A-5020. The "middle" part had two raised lugs on either side of center of the cross member, that held the Starting Crank Bearing, A-5461, (Style 1) in place, thus keeping it from shifting from side to side. Holes for "locating" the Starting Crank Bearing were later added to the cross member in January, 1928.

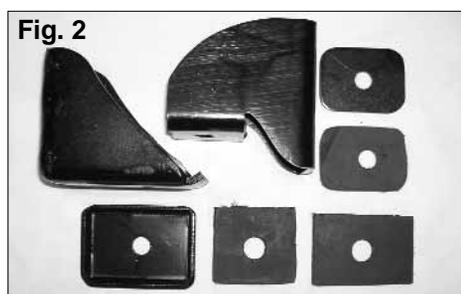
The Rear Engine Support Brackets (**Fig. 2**), A-5090-A, were originally riveted (**Fig. 3**) to the frame with four 3/16-inch rivets*. These brackets can be seen in the February, 1928 Ford Service Bulletin, Fig. 449, page 222 (**Fig. 4**). Some brackets

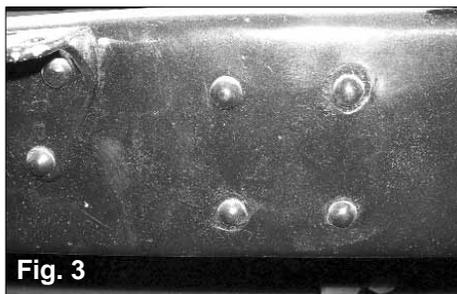
may have been bolted with 1/2 inch bolts and castle nuts and appeared on the first 1000 vehicles*.

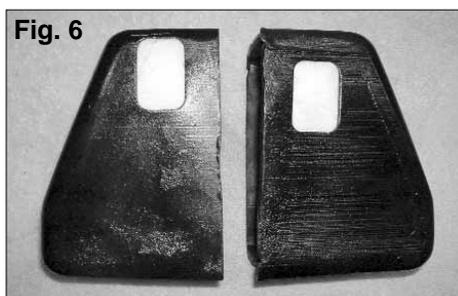
January also saw changes in the rectangular holes in the Rear Engine Support Bracket (**Fig. 6**). On some of the very early brackets, these holes did not exist as viewed on Tudor A2157. Whether it was

an error in the stamping process or not is not known. However when they were added, the holes were very close to the Flywheel Housing attachment. With the January 13, 1928, Release Number 6526, it indicated that the two rectangular holes were moved out 1/4 inch, changing the distance between the holes and the inside of the support from 1/4 to 1/2 inch. Also the Brake Retracting Spring Stud was to be removed from the left Frame Side Member because of a change to the new style Hand Brake Lever Retracting Spring, A-2744, in place of the Equalizer Operating Shaft Retracting Spring, A-2492, as was related in the February 15, 1928 Indianapolis Ford Service Letter due to “the new style brake rod support.” Thus, on January 25, 1928, the frame assembly was once again “brought up to date with changes in the side members.”

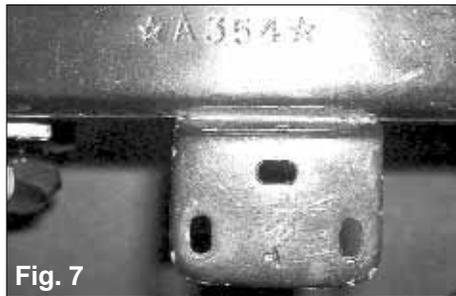
On February 21, 1928, the Hood Shelf Support Bracket A-5100 went from three holes (**Fig. 7**) to two holes (**Fig. 8**) on the top flange of the bracket and the Center Cross Member rivet holes reverted back to 17/64 inch. Bolt holes along with a grease zerk hole started to show up on the Frame Side Members right and left for the new style Emergency Brake Cross Shaft A-2828. The change over to the separate emergency brake system began as early as February, 1928 in some plants, but may have been as late as March, 1928 as indicated by the addition of the holes in the March 20 Release Number 7760. This was followed by the removal of the holes for the Brake Retracting Spring A-2492 on the back side and the removal of the holes for the Dual High Control Bracket on the front side of the Center Cross Member.

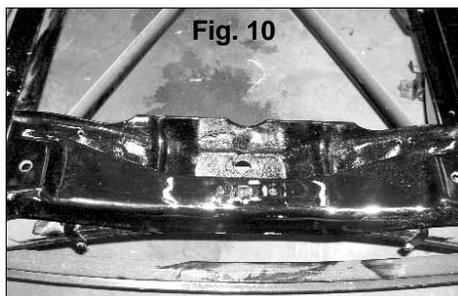
Fig. 10

In October, the Ford engineers were working on revising Frame Assembly, A-5005-B (Style 1). By October 11, 1928, Release Number 10580, Frame Assembly, A-5005-B (Style 2), was “brought up to date with changes necessitated by the new front engine support” (Fig. 10). What Ford did was revise the Front Cross Member so that the back of the rear flange was to be cut off 1-3/4 inches, thus removing the engine support holes which led to a new part, the Engine Front Support Assembly, A-6030-A. The size of the hole in the bottom of the cross member went from 1/2 inch to 3/4 inch diameter, which was used to accept the A-6034 brass bushing for the new engine support and the two holes formerly used with the engine pans were removed. The Starting Crank Bearing was also “redesigned” (Style 3), but retained the non-symmetrical lugs. The new cross member and related parts were brought forth in the November, 1928 Ford Service Bulletin thus Frame Assembly, A-5005-B (Style 2), began.

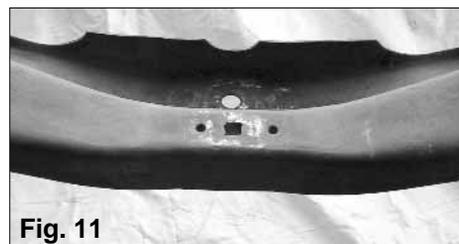
Fig. 11

On October 26, 1928, Release Number 10580 Supplement, saw yet another change in the Front Cross Member (Fig. 11). To simplify the dies, the reinforcing ribs were removed from the rear flange and the radius for the notch on top of the flange on the rear side was changed from 1-1/8 to 1-1/4-inch radius. Thus the beginning of Frame Assembly, A-5005-B (Style 3).

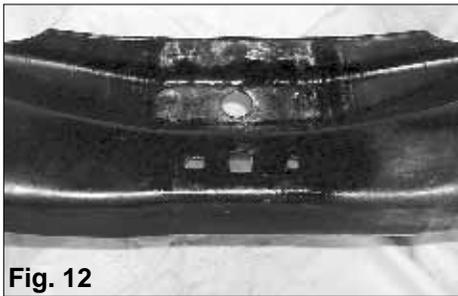
Fig. 12

March 15, 1929, Release Number 12280 saw a change in the Front Cross Member that "specified that one hole for lug on starting crank bearing be elongated instead of being round" (Fig. 12). This constituted a change in the Starting Crank Bearing, A-5461, (Style 4), in that it "changed distance between centerline of bearing and one locating lug from 1-1/8 to 1-3/8 (inch), making location of lugs symmetrical."

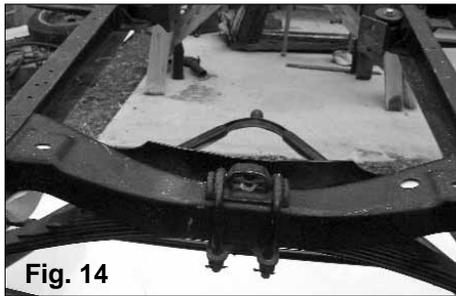
Fig. 14

With the incorporation of the sixth style Front Cross Member A-5020-B (Fig. 14), on September 30, 1929, Release Number 14053 Frame Assembly A-5005-B was "superceded by A-5005-C for production and service." Where the radiator mounting pad on Frame Assembly A-5005-B (Style 4), was "raised," or flush with the frame, the new Front Cross Member on Frame Assembly A-5005-C, had lowered this area to become "recessed." This feature shows up in the October, 1929 Ford Service Bulletin, page 387. October saw the Frame to Engine Rear Support Plate become a steel stamping with clipped corners (Fig. 16).

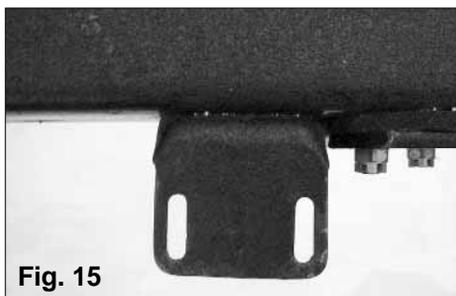
Fig. 15

On September 4, 1929, Release Number 13857, the width (length) of the horizontal pad on the Hood Shelf Support Bracket was changed from 1-3/4 inches to 2-3/32

inches and the length of the two slotted holes went from 3/16 inch to 19/32 inch (Fig. 15).

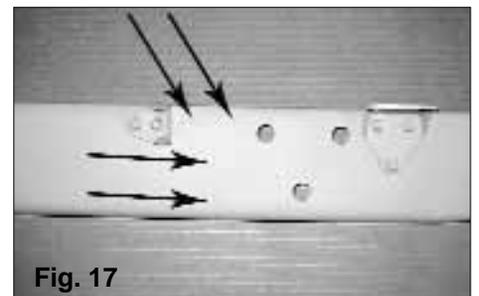
Fig. 17

December 5, 1929, saw the addition of a 7/8 inch hole on the Front Cross Member for the radiator overflow tube. By January, 1930, it was specified that the holes for the wheel carrier be drilled in place and that all frames were to be center punched to show the location of the holes (Fig. 17).
