FORD'S WAY

SQUEAK, SQUEAK, SQUEAK...WHERE IS MY ANTI-SQUEAK?

BY
STEVE PLUCKER

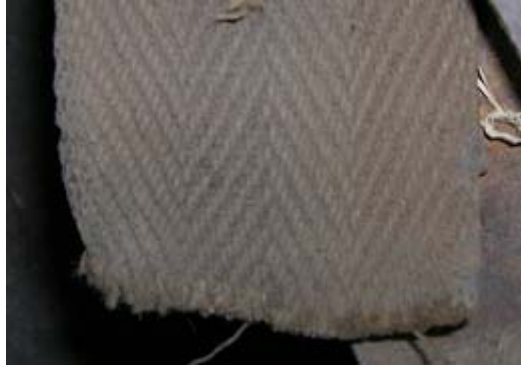
The first sample (**Fig. 1**) is from a very early 1928 (December 1927) Tudor Sedan, which was assembled at the Kearny Assembly Plant showing the “M-Webbing”.

The part became a "*New part (A-16540), released for production*" on November 9, 1927 with PR No. 4523. The part, "M-Webbing", (**Fig. 1 and 2**), as described on the Part Drawings and Part Releases, was 1/32 inches thick and 55-1/2 inches long on the first few assembled vehicles but the thickness of the material was changed on November 22, 1927, PR No. 5087, to 1/16 inch thick but was still 55-1/2 inches in length. The indicated width on the part drawings was 1-3/4 inches and each strip had seven (7) 1/2 inch holes for both bolt holes and rivet heads thus matching the hole position on the top frame rail.

However, the original "M-Webbing" on the very early 1928 Tudor Sedan and the January 1928 Open Cab (**Fig. 1 and 2**) were 2 inches in width in both cases but was not noted as such on the Part Drawings or Part Releases.

The PR also specified that "*Changed material specifications note from M-Webbing (Figs. 1 and 2) to Broken Twill Weave Napped Cotton Cloth (Figs. 3 and 4)*" and was to be treated with the Asphaltum treatment.

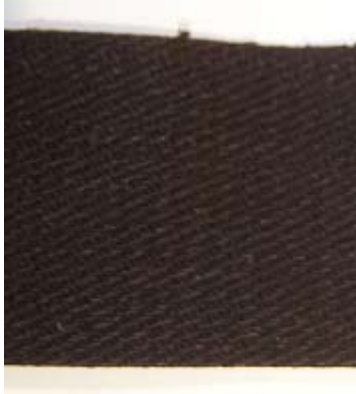
(Fig. 3)

The third sample (**Fig. 3**) is from an original A-16540 Running Board Shield to Frame Anti-Squeak strip showing the “Broken Twill Weave Napped Cotton Cloth”.

The “webbing” construction was the same “Broken Twill Weave Napped Cotton Cloth” as used with A-16540 and A-16541 (see **Fig’s 3 and 4** above).

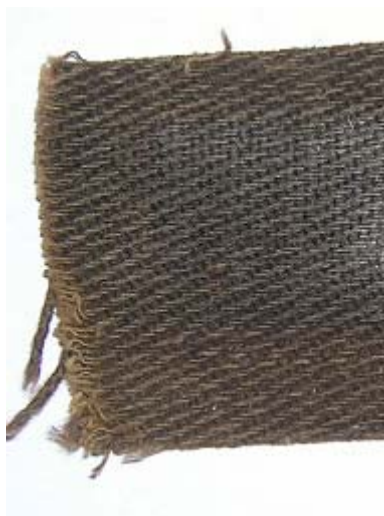
(Fig. 4)

The fourth sample (**Fig. 4**) is from a February-March 1929 Tudor Sedan which was assembled at the Seattle Assembly Plant showing the “Broken Twill Weave Napped Cotton Cloth”. This webbing has the same weave pattern as that which was also removed from a 1931 Victoria.

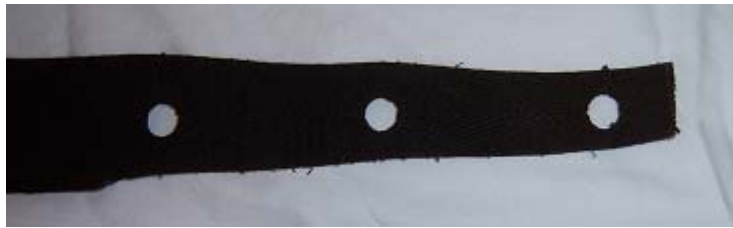
(Fig. 5)

Up to this time, the part, or strip, was rectangular in shape from one end to the other but on July 20, 1928, PR No. 9655, indicated "*Cut off end on an angle for a distance of 7 inches and 1 inch wide at end*". The "end" would have been the very front of the part and placed with the angled end to the inside of the frame rails as seen on the original sample of A-16540 **(Fig. 5)**.

An interesting note was that the original A-16540 that was on the February/March 1929 Tudor Sedan was the rectangular type and not the "cut" version as seen in **(Fig. 5)**.

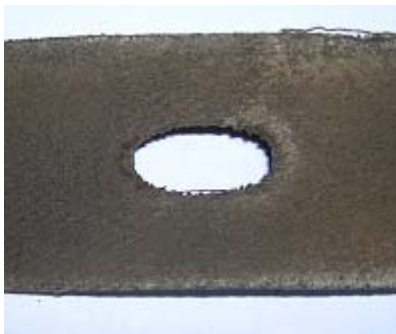
(Fig. 7)

To differentiate between the two, the strips with the $\frac{1}{2}$ inch round holes became A-16540-A (**Fig. 6**) and those with the $\frac{1}{2} \times \frac{3}{4}$ inch elongated holes became A-16540-B (**Fig. 7**) and were used with the new 1930 and 1931 Model A/AA vehicles. This designation first showed up in the March 1, 1930 Parts Price List.

On October 15, 1929, PR No. 14264, the shape of the seven holes within the strip itself were changed. The PR related the following: "*Changed seven holes from 1/2 round to 1/2 x 3/4 elongated holes and added affected sizes*", which continued as such through the end of production **(Fig. 6 and 7)**.

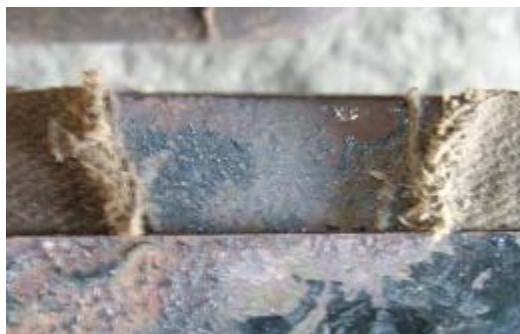
(Fig. 8)

It was noted on the February/March 1929 Tudor Sedan that there was a 3/4 to 1 inch gap between the placement of A-16540 Running Board Shield to Frame Anti-Squeak (Front) and A-16541 Running Board Shield to Frame Anti-Squeak (Rear) when both strips were laid on the top of the frame rails, both left and right sides. **(Fig. 8)** shows the two strips with the Running Board Shield in place and **(Fig. 9)** with the Running Board Shield removed.
