# **FORD'S WAY**

**THE FRONT AND REAR BRAKE GREASE BAFFLES  
AND OTHER RELATED ITEMS**

**STEVE C. PLUCKER**

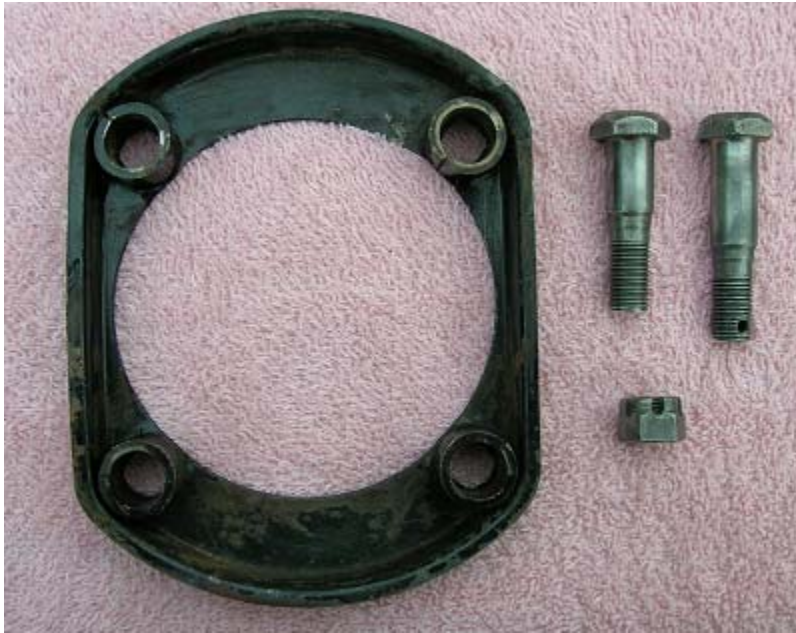
**Fig. 1**

The first type Rear Brake Grease Baffle Assembly (**Fig. 1**) was used in Model A production from Start of Production thru April-June 1928 before the separate emergency brake system was introduced.

This assembly (A-2239) included the “thin” sheet metal plate baffle (A-2240) and four spacers (A-2241) which were attached to the inside cavity of the plate. The assembly was approximately 5/8 inches in depth.

Average spacer height is about 0.632 inches. Between 41/64 and 5/8 inch.

The correct placement of this part in relation to the Rear Backing Plate, (according to the wear marks viewed on the baffle itself), is to place the baffle so as the spacers and the outside lip of the baffle go against the Rear Backing Plate.

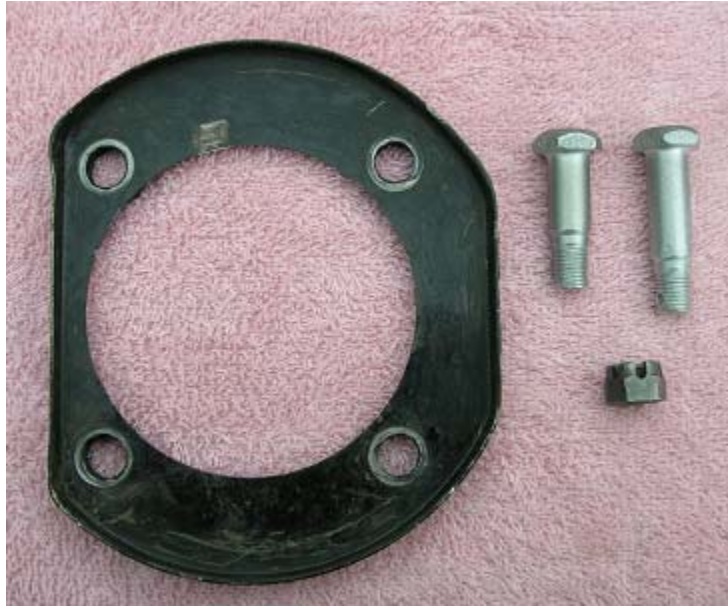
**Fig. 2**

The second type Rear Brake Grease Baffle Assembly (**Fig. 2**), which was made from surplus sheet metal of the radiator shell, was “*Adopted*” in April-1928 when the separate emergency brake system was introduced.

This assembly (A-2239-B) included the “thin” sheet metal plate baffle (A-2240-B) and four spacers (A-2241-B) which were attached to the outer face of the plate. The assembly was approximately 5/8 inches in depth but utilized shorter bolts than A-2239.

The assembly started out as being Cadmium Plated but was quickly changed to Black Enamel.

Average spacer height is about 0.306 inches. Between 5/16 and 19/64 inch.

The correct placement of this part in relation to the Rear Backing Plate, (according to the wear marks viewed on the baffle itself), is to place the baffle so as the spacers of the baffle go against the A-2600/A-2601 Emergency Brake Carrier Plate Assembly (which is then assembled to the Rear Backing Plate).

The second type baffle (**Fig. 2**) fit into the “new” A-2600 (RH)/A-2601 (LH) Emergency Brake Carrier Plate Assembly which had a single thickness emergency brake stop (**Fig. 3**) along with many other parts related to the new and separate emergency brake system that were all drawn up in the month of March 1928.

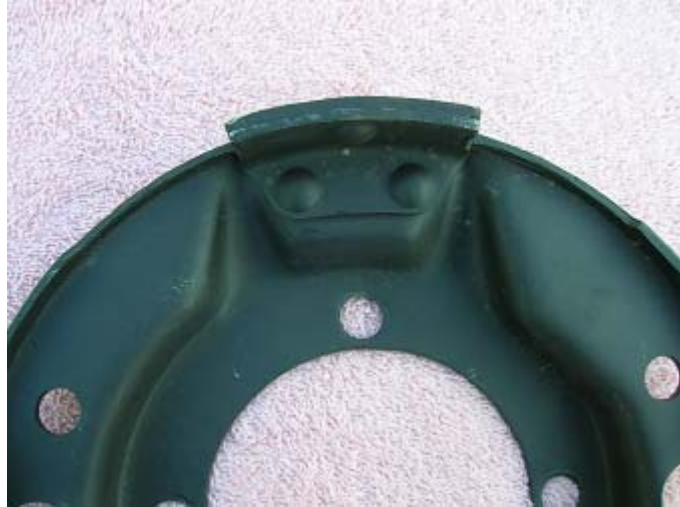
**Fig. 4**

By August 1928, or there about, a second Emergency Brake Carrier Plate Assembly was adopted when a “reinforcement plate” was attached to the assembly with three rivets to strengthen the area where the two ends of the Emergency Brake Band came in contact with the Emergency Brake Band Stop on the plate itself (**Fig. 4**). This was probably due to the weakness of the initial carrier plate as seen in the damaged plate (**Fig. 5**).

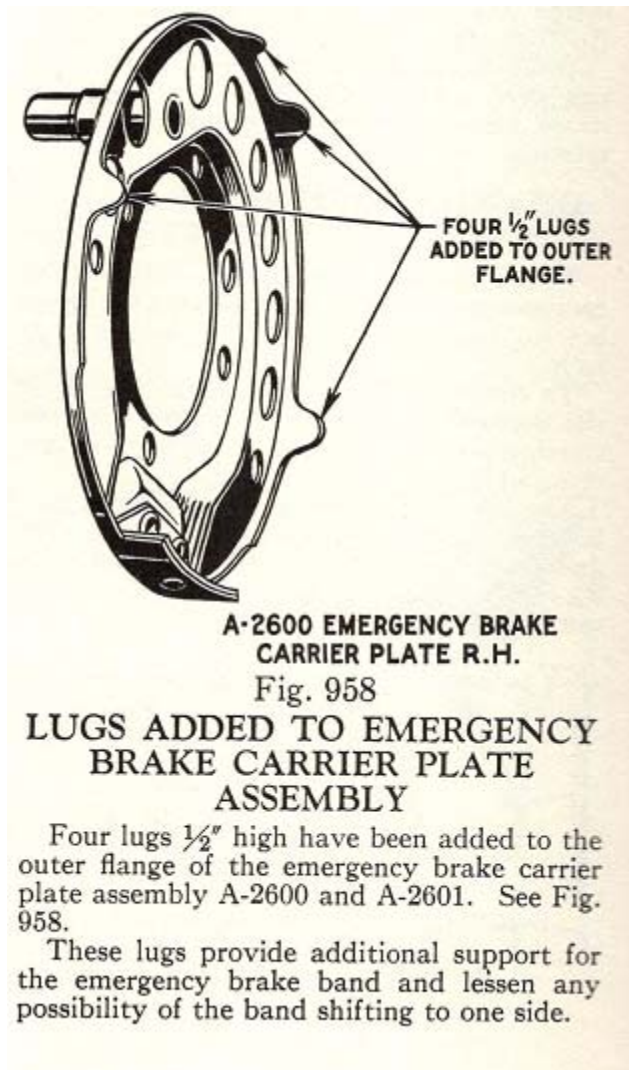
**Fig. 6**

Sometime in 1930, according to the August 1930 Ford Service Bulletin, four (4)  $\frac{1}{2}$ " lugs were added to the outer flange of the A-2600/A-2601 Emergency Brake Carrier Plate Assembly (**Fig. 6**).

This final assembly of the Emergency Brake Carrier Plate Assembly is interchangeable with the previous two assemblies and lasted thru the end of the production of the Model A Ford.

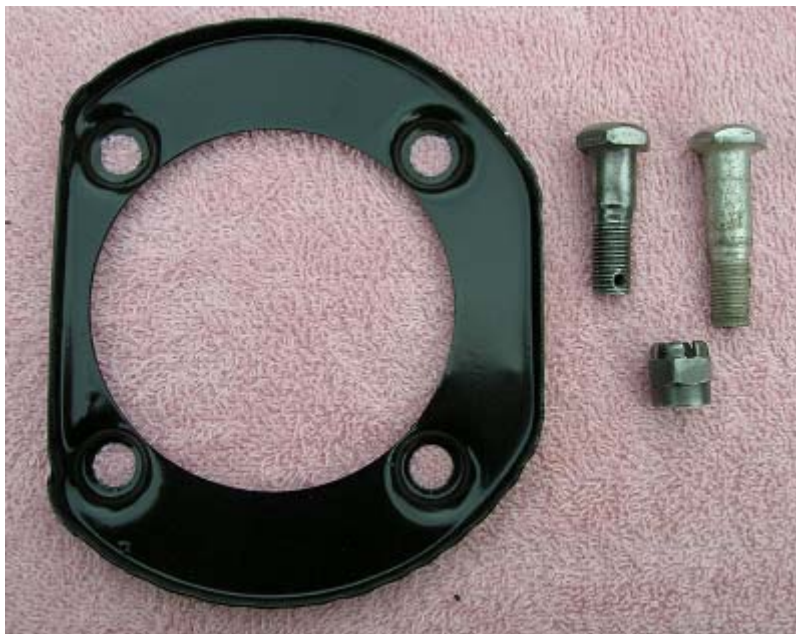
**Fig. 7**

The third and final type Rear Brake Grease Baffle (A-2240-B) (**Fig. 7**), now no longer an assembly, was introduced about November 6, 1928 when the spacers were no longer required.

This was just a single stamped sheet metal plate that *“Added four pockets at the bolt holes”*. The baffle was approximately 5/8 inches in depth and used the same bolts as A-2239-B BUT with a different shank configuration because of the lack of attached spacers on the plate. It took a special castle nut for attachment as seen in **Fig. 7**.

**NOTE: Special Castle Nut A-21801 shows up in the Parts Price Lists (PPL) on June 1, 1929 within the Standards Parts section. HOWEVER it did not appear in the Service Brake section of the PPL until July 1, 1931. This nut was lengthened in which a “special” shoulder was added to the bottom so it would go into the cavity/pockets of the plate itself thus the change in the bolt shanks.**

The correct placement of this part in relation to the Rear Backing Plate, (according to the wear marks viewed on the baffle itself), is to place the baffle so as the four pockets of the baffle go against the A-2600/A-2601 Emergency Brake Carrier Plate Assembly (which is then assembled to the Rear Backing Plate).

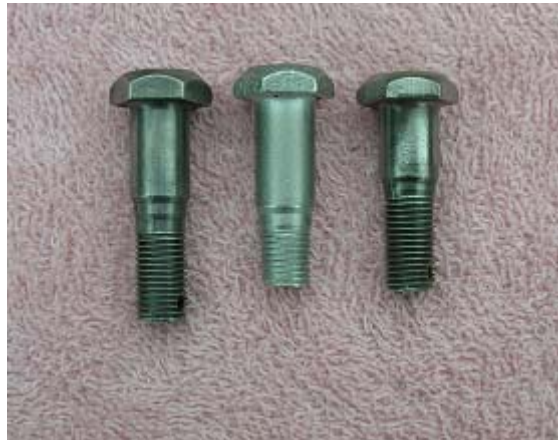
**Fig. 8 (Short bolts)**

#1 bolt on the left side (A-21211) is for #1 assembly and takes castle nut (A-21791) which measures 7/16---20 (29/64 x 5/8);

#2 bolt in the middle and #3 bolt on the right side (both A-21151) are for #2 and #3 assemblies accordingly.

HOWEVER #2 bolt uses A-21791 castle nut where #3 bolt uses A-21801 special castle nut, a 7/16---20 x (43/64 x 5/8). This is the special castle nut that fits within the cavity of the #3 baffle.

These nuts and bolts are positioned to the rear of the assembly. Two are required each assembly.

**Note the shank differences in the three bolts.**

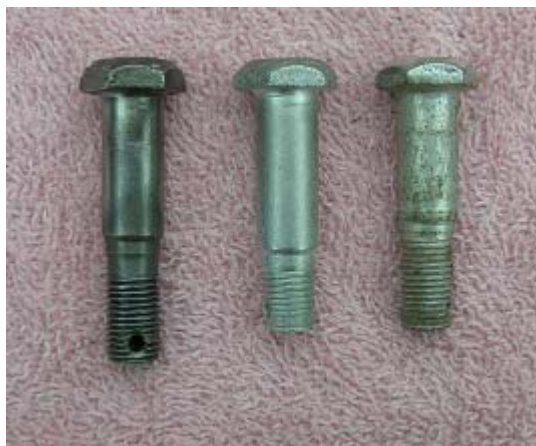
**Fig. 10 (Long bolts)**

#1 bolt on the left side (A-21210) is for #1 assembly and takes castle nut (A-21791) which measures  $7/16$ ---20 ( $29/64 \times 5/8$ );

#2 bolt in the middle and #3 bolt on the right side (both A-21152) are for #2 and #3 assemblies accordingly.

HOWEVER #2 bolt uses A-21791 castle nut where #3 bolt uses A-21801 special castle nut, a  $7/16$ ---20 x ( $43/64 \times 5/8$ ). This is the special castle nut that fits within the cavity of the #3 baffle.

These nuts and bolts are positioned to the front of the assembly attaching the Rear Radius Rods to the Rear Backing Plates. Two are required each assembly.

**Note the shank differences in the three bolts.**

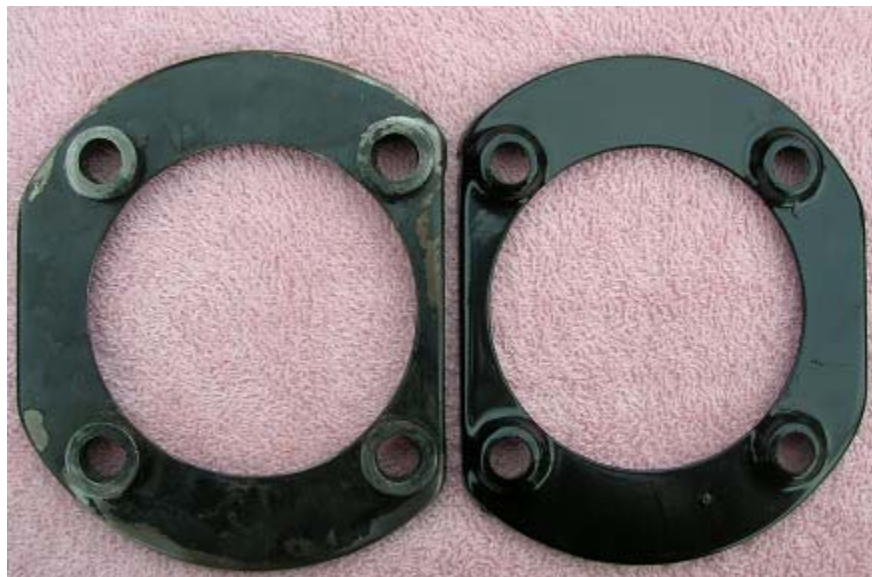
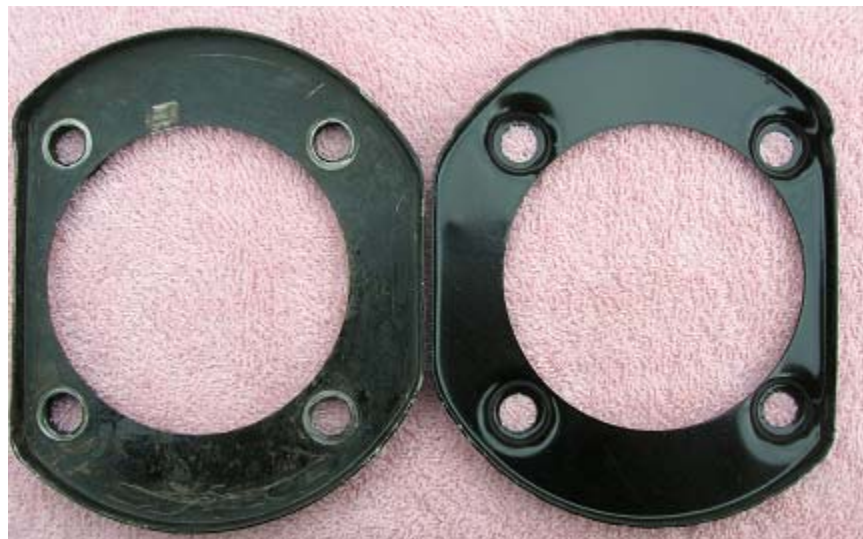
**Figures 12 and 13** compares each side with the other of A-2239-B on the left and A-2240-B on the right.

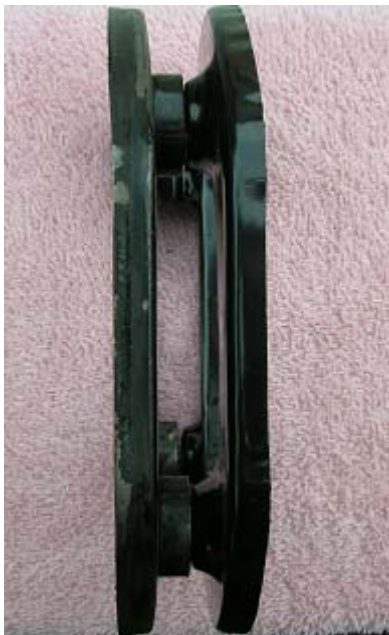
**Fig. 14** compares the spacers/shoulders of A-2239-B on the left and A-2240-B on the right.

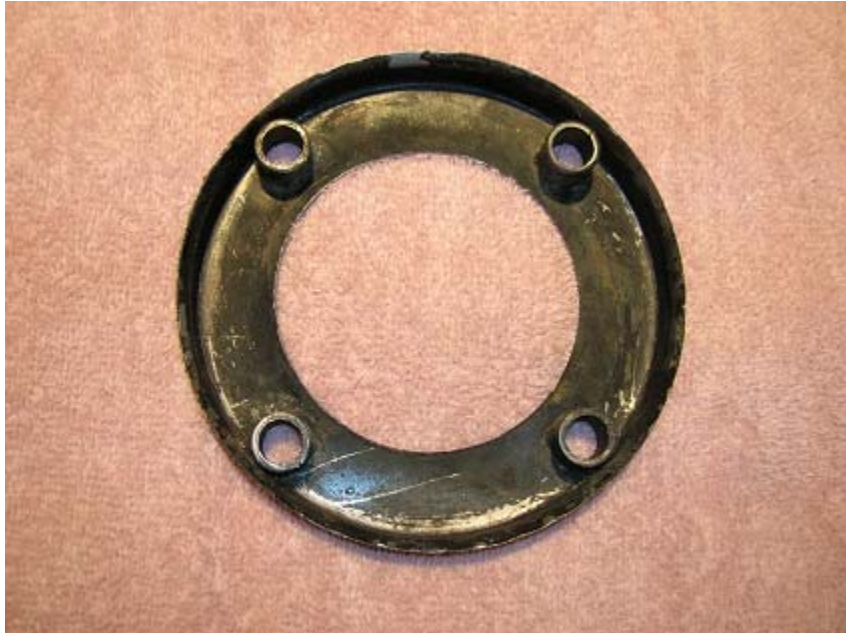
**Fig. 15**

The first type Front Brake Grease Baffle Assembly (**Fig. 15**) was used in Model A production from Start of Production and used with the forged hubs only thru about April 1928 or there after.

This assembly (A-2059 then changed to AA-2059) included the “thin” sheet metal plate baffle (A-2060) and four spacers (A-2061) which were attached to the inside cavity of the plate. The assembly was approximately 0.560 inches in depth.

The bolt (A-20919) used with this assembly was 3/8---24 SAE x 1-5/16 Hex head bolt with hole in the end. This designation or size was in all Parts Price Lists (PPL's) up thru March of 1930. Thereafter all PPL's listed it as 3/8—24 SAE x 1-1/32. This was an error.

The castle nut (A-21745) used with this assembly measured 3/8---24 SAE (13/32 x 9/16).

The correct placement of this part in relation to the Front Backing Plate, (according to the wear marks viewed on the baffle itself), is to place the baffle so as the spacers and the lip of the baffle go against the Front Backing Plate.

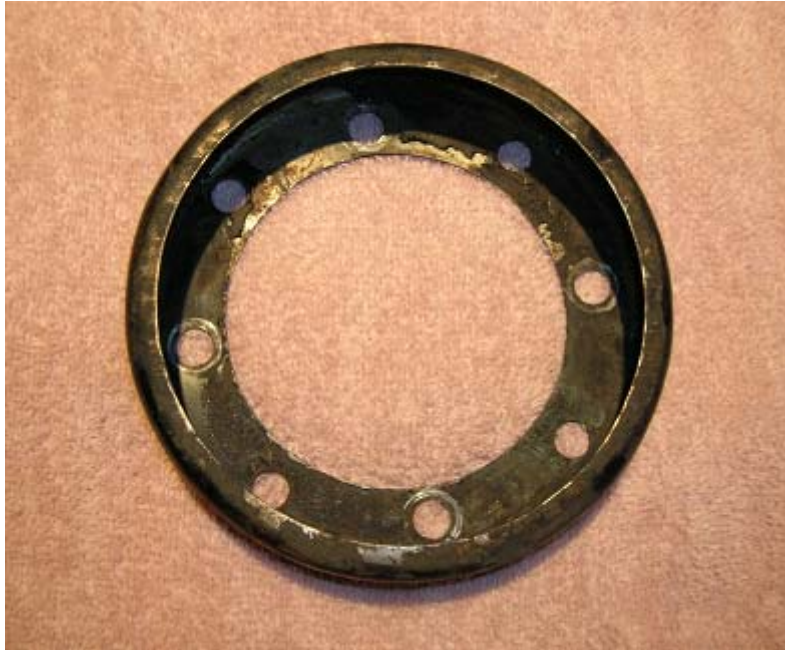
**Fig. 16**

The second and final type Front Brake Grease Baffle (A-2060-B) (**Fig. 16**), now no longer an assembly, was introduced about April 1928 when the spacers were no longer required. It was specified to use with the pressed steel hubs.

This was just a single stamped sheet metal plate.

The bolt (A-20949) used was a 3/8—24 NF x 13/16 Hex head bolt with hole in the end.

The castle nut (A-21745) used measured 3/8---24 SAE (13/32 x 9/16).

The correct placement of this part in relation to the Front Backing Plate, (according to the wear marks viewed on the baffle itself), is to place the baffle so as the holes of the baffle are in direct contact and against the Front Backing Plate.
