THE MODEL A FORD STARTING CRANK BEARING

A-5461 and Related Parts

By Steve Plucker, Touchet, Washington

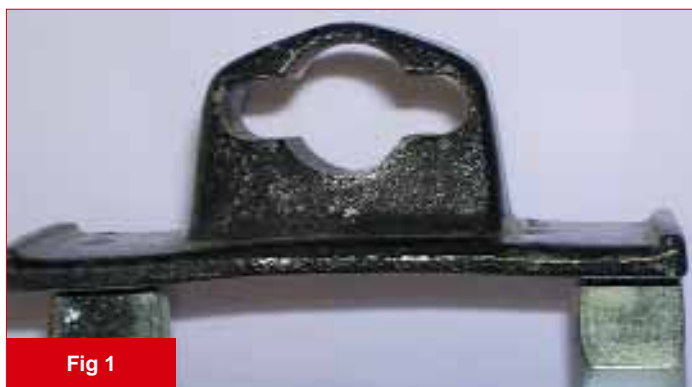
Style 1, (**Fig. 1**), which was released for production on July 26, 1927, EDF 1471, had the following features. The hole diameter was 45/64 inches with the width of the bottom pocket being 15/16 inches; the ends of the slots were rounded, but the slots themselves were 21/64 inches in width; there was a slight curve to the bottom; and the thickness of the plate at the center was 3/16 inch. The top of the bearing was sloped on both sides and was a forging.

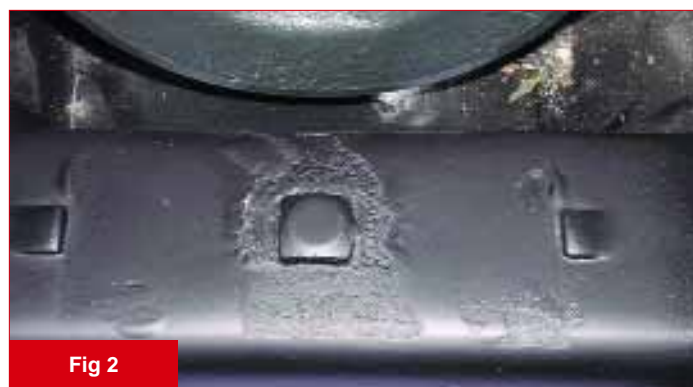
This bearing was used with the three-piece Front Cross Member with the punched up “tabs” on both sides (**Fig. 2**) of the square hole for the spring “I” bolt. The “tabs” were to prevent the Starting Crank Bearing from shifting right or left as there were no locating holes in the cross member for the bearing itself.

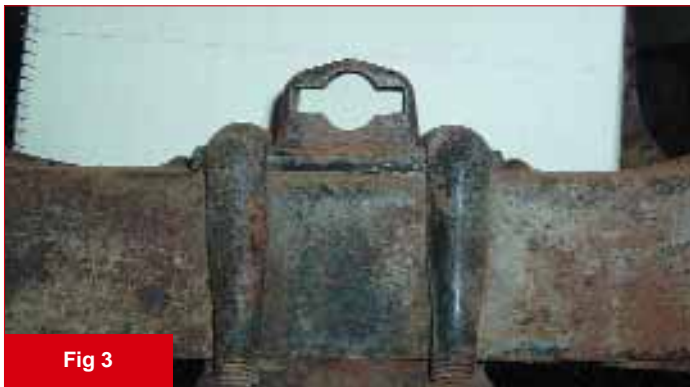
Fig 7

On September 19, 1928, Release Number 10295, it indicated that the two spherical bosses were removed from top at center, thus the two rivet head type bosses were deleted from the Front Cross Member (**Fig. 7**).

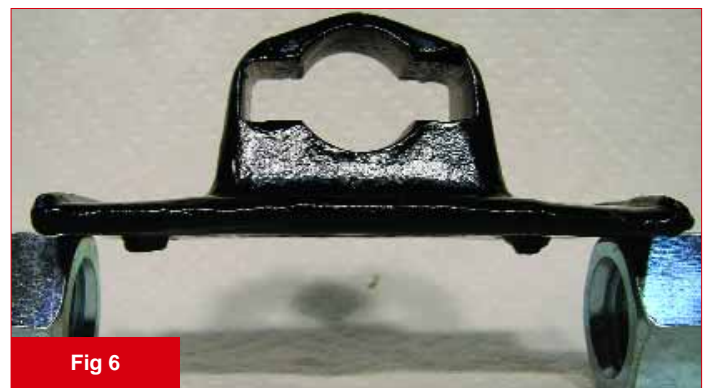
Fig 15

All of the above Starting Crank Bearings used Front Spring Clip, A-5455-A, (**Fig. 15**).

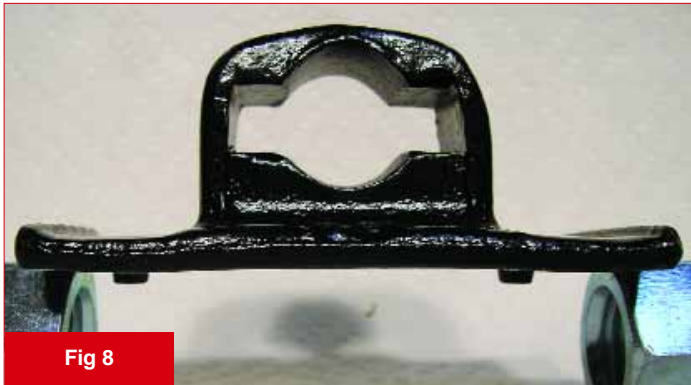
Fig 8

The bearing was redesigned to Style 4 (**Fig. 8**) on October 3, 1928, Release Number 10468. The top was changed from being sloped on both sides to a more square looking top and was thicker in appearance. It was also changed from a Hot Rolled Steel forging to Malleable Iron and continued to have the two 1/4-inch diameter non-symmetrical bosses on the bottom.

A slight change to Style 4 occurred on December 6, 1928, Release Number 11250, where it specified that the slot and the hole for the starting crank be parallel to the bottom face instead of being at a 1-1/2 degree angle.

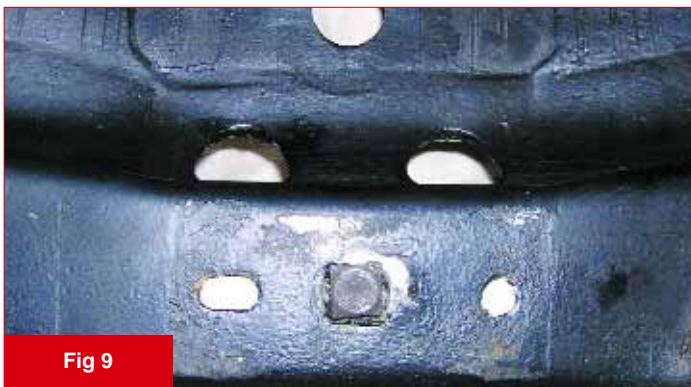
Fig 9

On March 15, 1929, Release Number 12280, it specified that on the Frame Front Cross Member, one hole for the lug on the Starting Crank Bearing be elongated instead of being round (**Fig. 9**). The Starting Crank Bearing, therefore, changed to Style 5

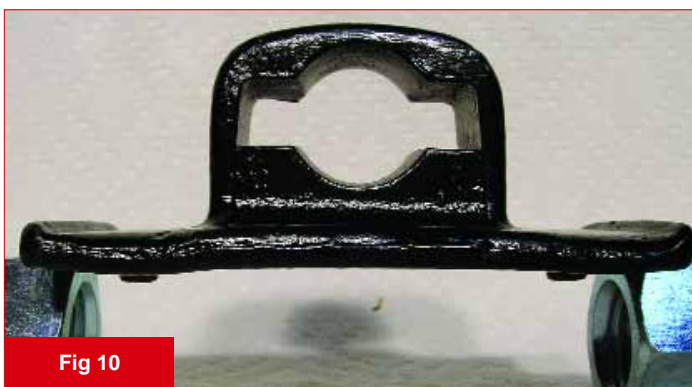
Fig 10

(**Fig. 10**) thus changing the distance between the centerline of the bearing and one locating lug from 1-1/8 inch to 1-3/8 inch, making the location of the lugs symmetrical. It also specified that the 3/4-inch diameter cored hole be rounded with a two-inch radius instead of being straight (not sure what that means).

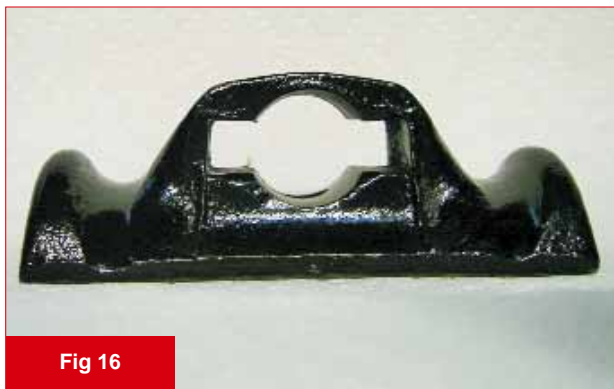
Fig 16

By August, 1929, a new style Starting Crank Bearing, A-5461-B, Style 6, (Fig. 16), along with the “new” style Front Spring Clip, A-5455-B, (Fig. 17), had come into play. It was referred to as “A-5461-B-Exp. Mfg. design.” It is not immediately known just when this part showed up on the assembly line, maybe with the introduction of the “new” style Frame Front Cross member, A-5020-B with the lowered radiator pads, but on January 27, 1930, the “Exp. Mfg.” was removed from the symbol numbers and it was specified for full production on 1929-1930 A and AA Chassis. The part is also represented in the February 1930 Ford Service Bulletin as a “new” part and continued as such through production for use on vehicles with the 10-leaf Front Spring Assembly.

On July 1, 1930, Release Number 16984, the width of the section through the crank bearing hole was changed from 7/8 inch to 27/32 – 29/32 inch.

On September 2, 1930, the locating lugs on the bottom of the bearing were changed slightly from 1-3/8 to 1-25/64 inch of centerline of hole and centerline of locating lugs.
